DOT/FAA/AR-00/18

Development of Supplemental Inspection Report for the Fairchild Metro SA226 and SA227 Airplane

April 2000

Final Report

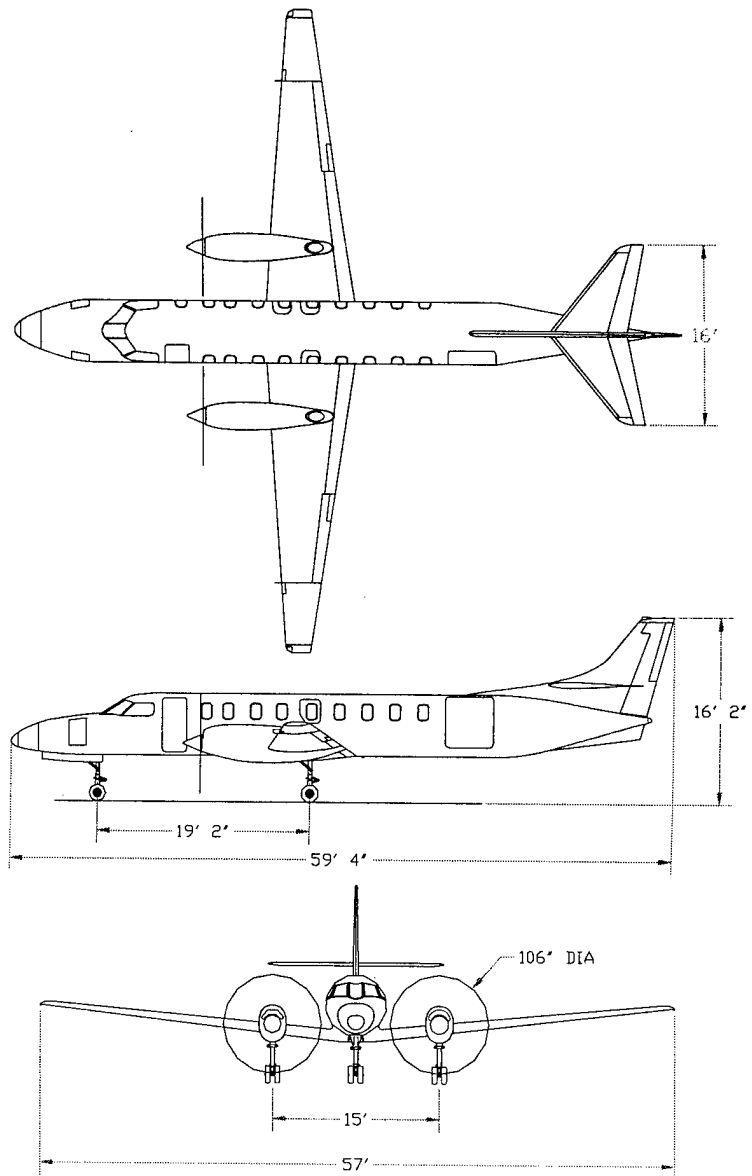
DATA	
BASIC DIMENSIONS	
LENGTH	59' 0"
HEIGHT	16' 8"
SPAN	57' 2"
WING DATA	
AREA:	
WING (TOTAL)	308.1 SQ FT
AILERON (TOTAL)	14.12 SQ FT
FLAP SLOTTED (TOTAL)	40.66 SQ FT
AIRFOIL:	
ROOT	NACA65 A215
TIP	MODIFIED NACA64 A415
ASPECT RATIO, AR	10.59
MAC	72.3 IN
SWEEP AT QUARTER CHORD	0.9 DEG
TAPER RATIO	.257
DIHEDRAL (WRP AT 32% CHORD)	5 DEG
ANGLE OF INCIDENCE:	
ROOT	+1 DEG
TIP	-2.69 DEG
GEOMETRIC TWIST	-3.69 DEG
POWERPLANT DATA	
ENGINES:	
TWO AIRESEARCH TPE331-12UA-701G (MAX CONT.)	1100 SHP
PROPELLERS:	
TWO 4 BLADED FULL FEATHERING	106 IN DIA
LANDING GEAR DATA	
MAIN GEAR (DUAL WHEELS)	
TOTAL STRUT STROKE	10 IN
TIRE (TUBELESS) 19.5 X 6.75-8,PLY RATING=10	
WHEEL	18 X 5.5
NOSE GEAR (DUAL WHEELS)	
TOTAL STRUT STROKE	8 IN
TIRE (TUBELESS) 18 X 4.4, PLY RATING=10	
WHEEL	18 X 4.4
SPECIFICATIONS	
WEIGHTS:	
TAKEOFF WEIGHT	16,500 LBS
EMPTY WEIGHT	8,680 LBS
LANDING WEIGHT	15,675 LBS
ZERO FUEL WEIGHT	14,500 LBS
PERFORMANCE	
SPEEDS:	
$V_{LO} = V_{LE} = 248$ KNOTS, CAS

$V_{LO} = 311$ KNOTS, CAS	
MAX. OPERATING ALTITUDE	25,000 FT
EMPENNAGE DATA	
HORIZONTAL TAIL:	
AREA, TOTAL (INCLUDING FUSELAGE)	75,970 SQ FT
AREA, STABILIZERS (TOTAL)	54.7 SQ FT
AREA, ELEVATORS (TOTAL)	21.27 SQ FT
AIRFOIL SECTION:	
ROOT	MODIFIED NACA66A009
TIP	MODIFIED NACA63A009
INCIDENCE	VARIABLE
DIHEDRAL	0 DEG
VERTICAL TAIL:	
AREA, TOTAL (INCLUDING DORSAL)	56.0 SQ FT
AREA, (VERTICAL STABILIZER)	24.036 SQ FT
AREA, RUDDER	19.38 SQ FT
AREA, DORSAL FIN	10.583 SQ FT
AIRFOIL SECTION	
ROOT	MODIFIED NACA66A009
TIP	MODIFIED NACA63A009
AREA, VENTRAL	5.48 SQ FT

FIGURE 1. SA227 BASIC GEOMETRY

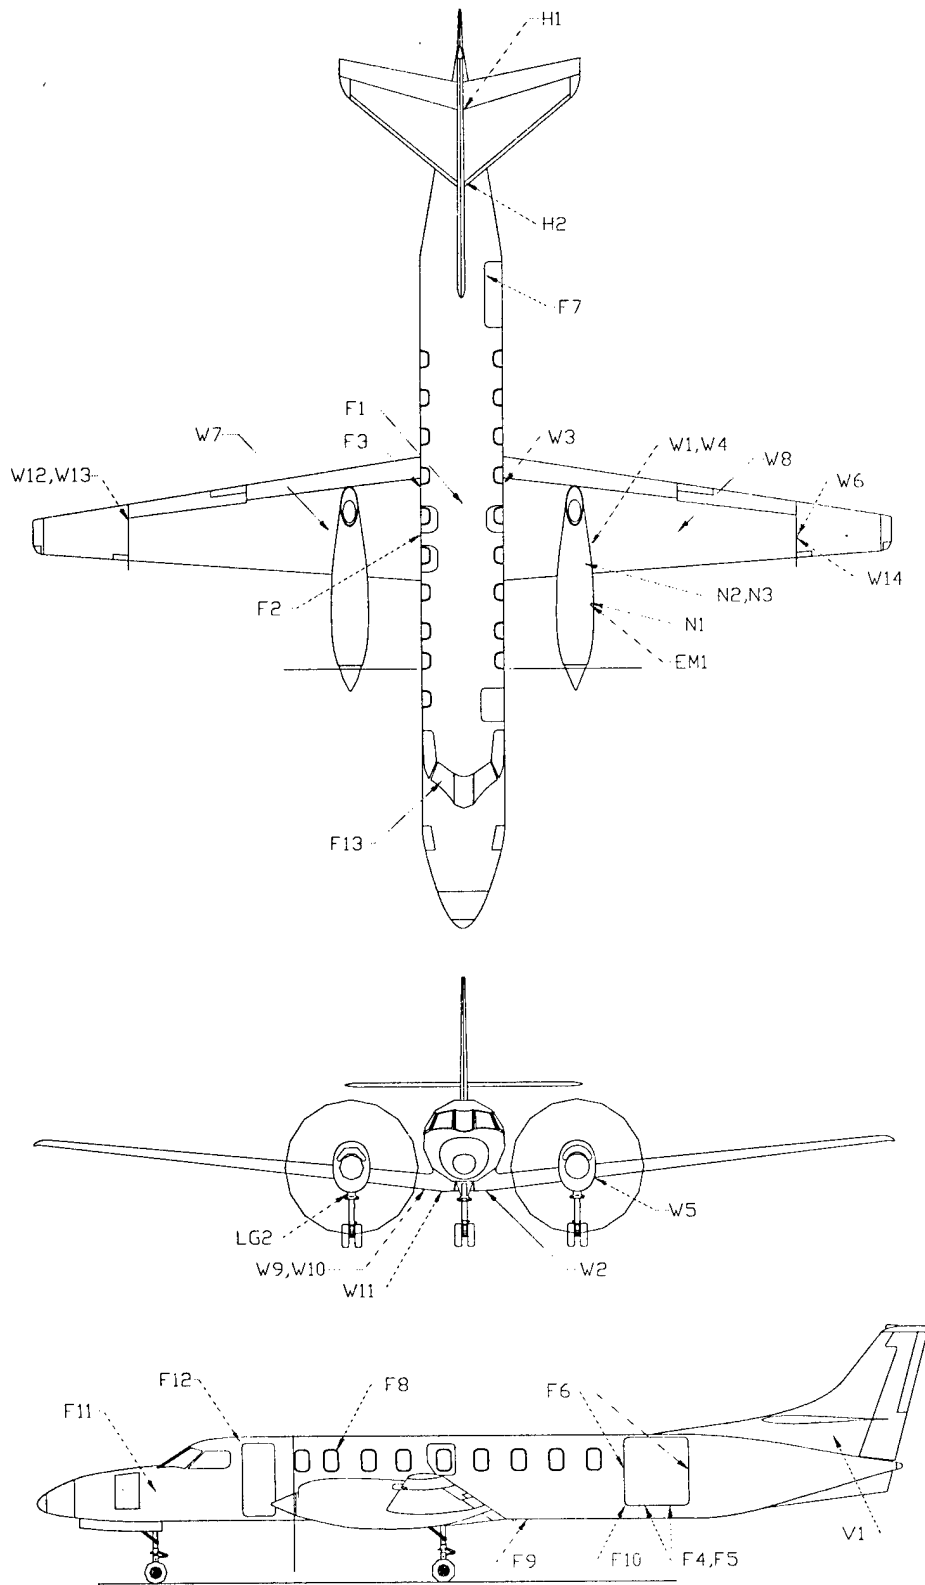
Table 4 presents the PSE critical areas selected for damage tolerance analysis. Figure 4 shows the locations of the critical areas. They are also depicted in reference 3.

FIGURE 4. LOCATIONS OF CRITICAL AREAS

F3	SA226 and SA227 Wing-fuselage aft attachment fittings
F4	SA226 and SA227 Fuselage frame at fore/aft cargo door latches @ FS 454.5/455.7 and 473.4/474.6
F5	SA226 and SA227 Fuselage frame at fore/aft cargo door latches @ FS 455.7/473.4
F6	SA226 and SA227 Fuselage frame at cargo door sides
F7	SA226 and SA227 Cargo door hinge
F8	SA226 and SA227 Corners of passenger window cutouts
F9	SA226 T-stringer at bottom centerline aft of FS 362
F10	SA226 and SA227 Cargo door opening corners
F11	SA226 and SA227 Forward pressure bulkhead
F12	SA226 and SA227 Passenger door opening corners
F13	SA226 and SA227 Control column roller bearing
H1	SA226 and SA227 Rib strap at horizontal stabilizer rear spar @ BL 3.135
H2	SA226 and SA227 Horizontal stabilizer pitch trim actuator fittings
N1	SA226 and SA227 Nacelle upper longeron at firewall
N2	SA226 and SA227 Nacelle upper longeron at attachment to wing rib attach angles at main spar

N3	SA226 and SA227 Nacelle upper longeron to wing rib attach angles at wing rib
V1	SA226 and SA227 Vertical fin main spar cap strips at bottom of pivot fitting
EM1	SA227 Engine mount at firewall
LG2	SA226 and SA227 Landing gear cylinder 5453001-1,-3

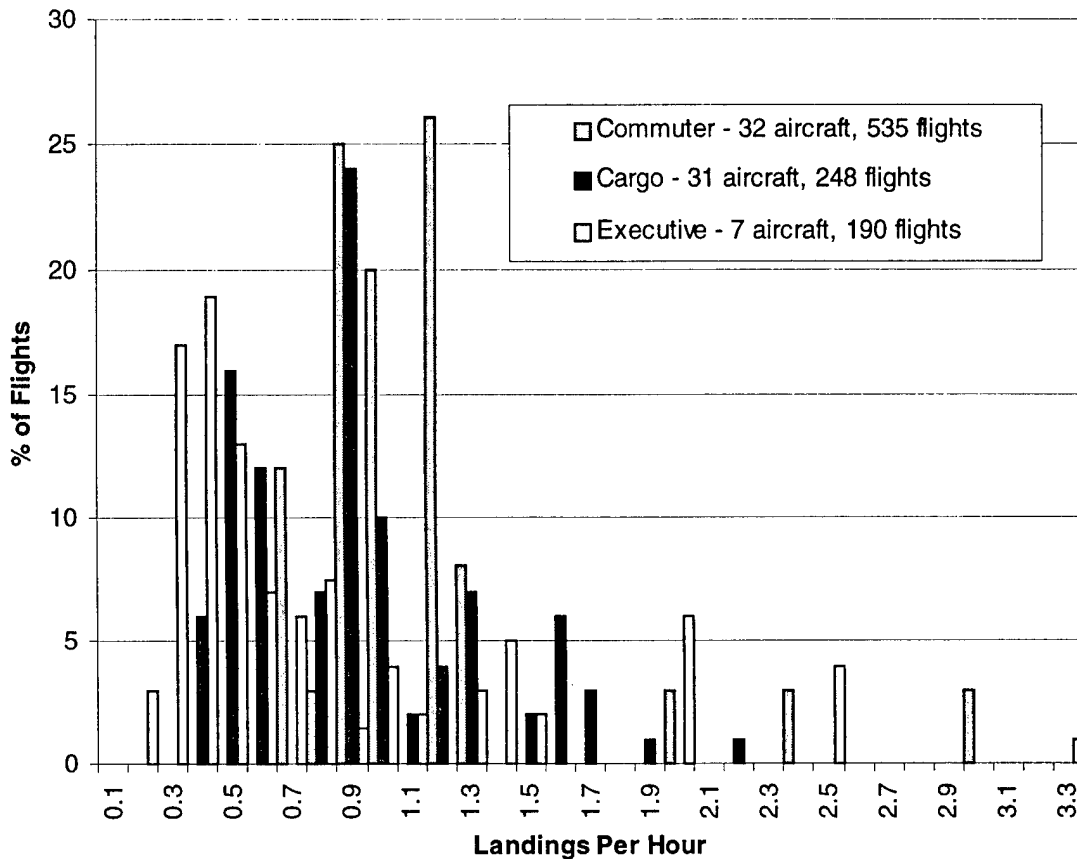
Additional information was gathered from the Official Airline Guide and teleconferences with operators. A graphical summary of the usage data from the survey is shown in Figure 1.

Figure 1. Flight Length Summary (Sheet 1)

- Two commuter operators: 535 flights with 32 aircraft
- One cargo operator: 248 flights with 31 aircraft
- One executive operator: 190 flights with 7 aircraft

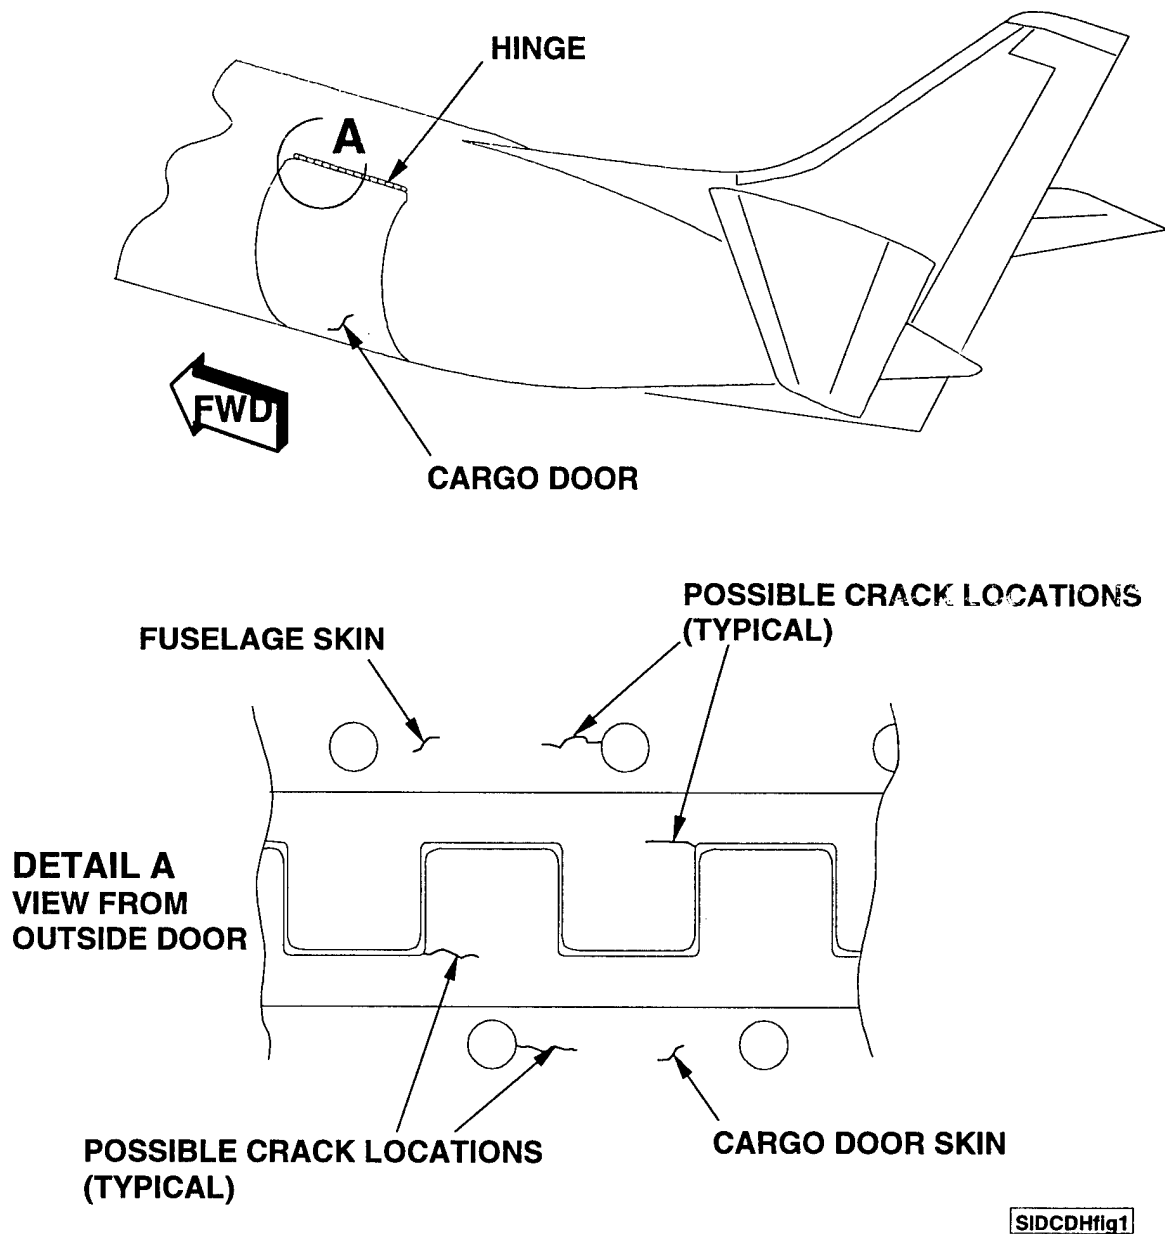
1. Adhere to procedures for Eddy-Current Inspection given in the SA226/227/227CC Structural Repair Manual, Chapter 51-30-07.
2. Refer to Figure 1. Inspect the hinge tabs and around fastener holes along the length of the hinge. Inspect the top piece (on fuselage) and bottom piece (on cargo door). Observe the phase and amplitude changes on the instrument.
3. Cracks are most likely to occur near the ends of the hinge.
4. If an indication is noted, carefully repeat the inspection pass in the opposite direction to verify the indication.
5. All cracks detected shall be reported to Fairchild Service Engineering. Report the location, direction, and length of each crack.

Figure 1. SA226/SA227 Cargo Door Hinge

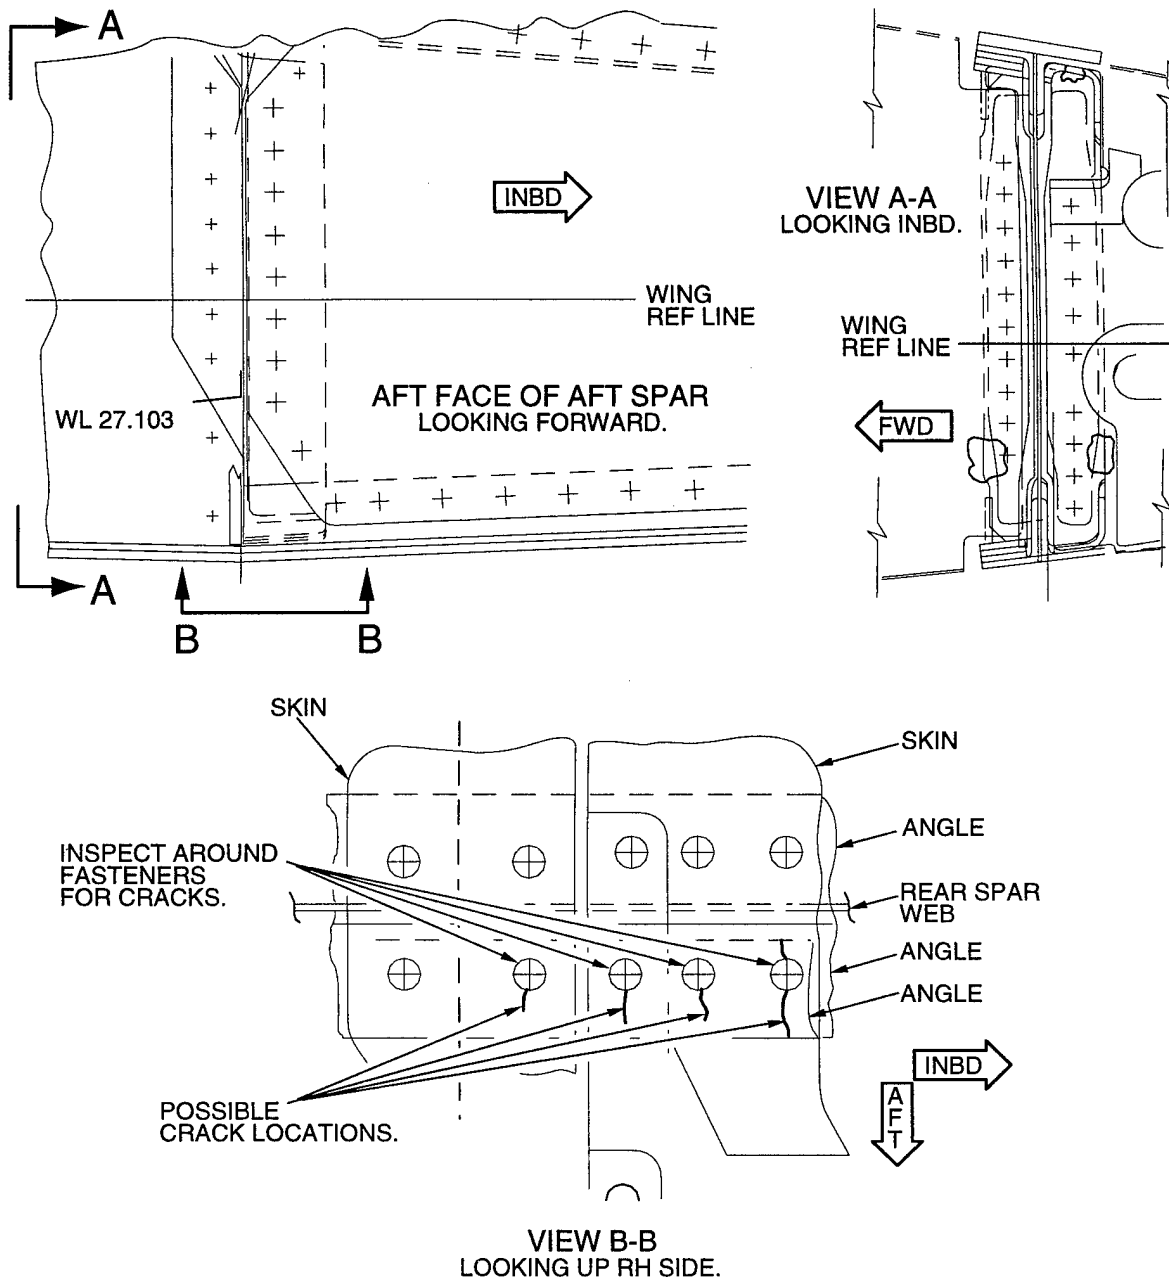
226RSLC1

1. Adhere to procedures for Eddy-Current Inspection given in the SA226/227 Structural Repair Manual, Chapter 51-30-07.
2. Refer to Figure 1. Inspect aft aluminum spar cap angle around the fastener holes between stations 24 and 27, left and right wing. Observe the phase and amplitude changes on the instrument.
3. If an indication is noted, carefully repeat the inspection pass in the opposite direction to verify the indication.
4. All cracks detected shall be reported to Fairchild Service Engineering. Report the location, direction, and length of each crack.

SA226 WING REAR SPAR LOWER CAP AT WS 27
 FIGURE 1

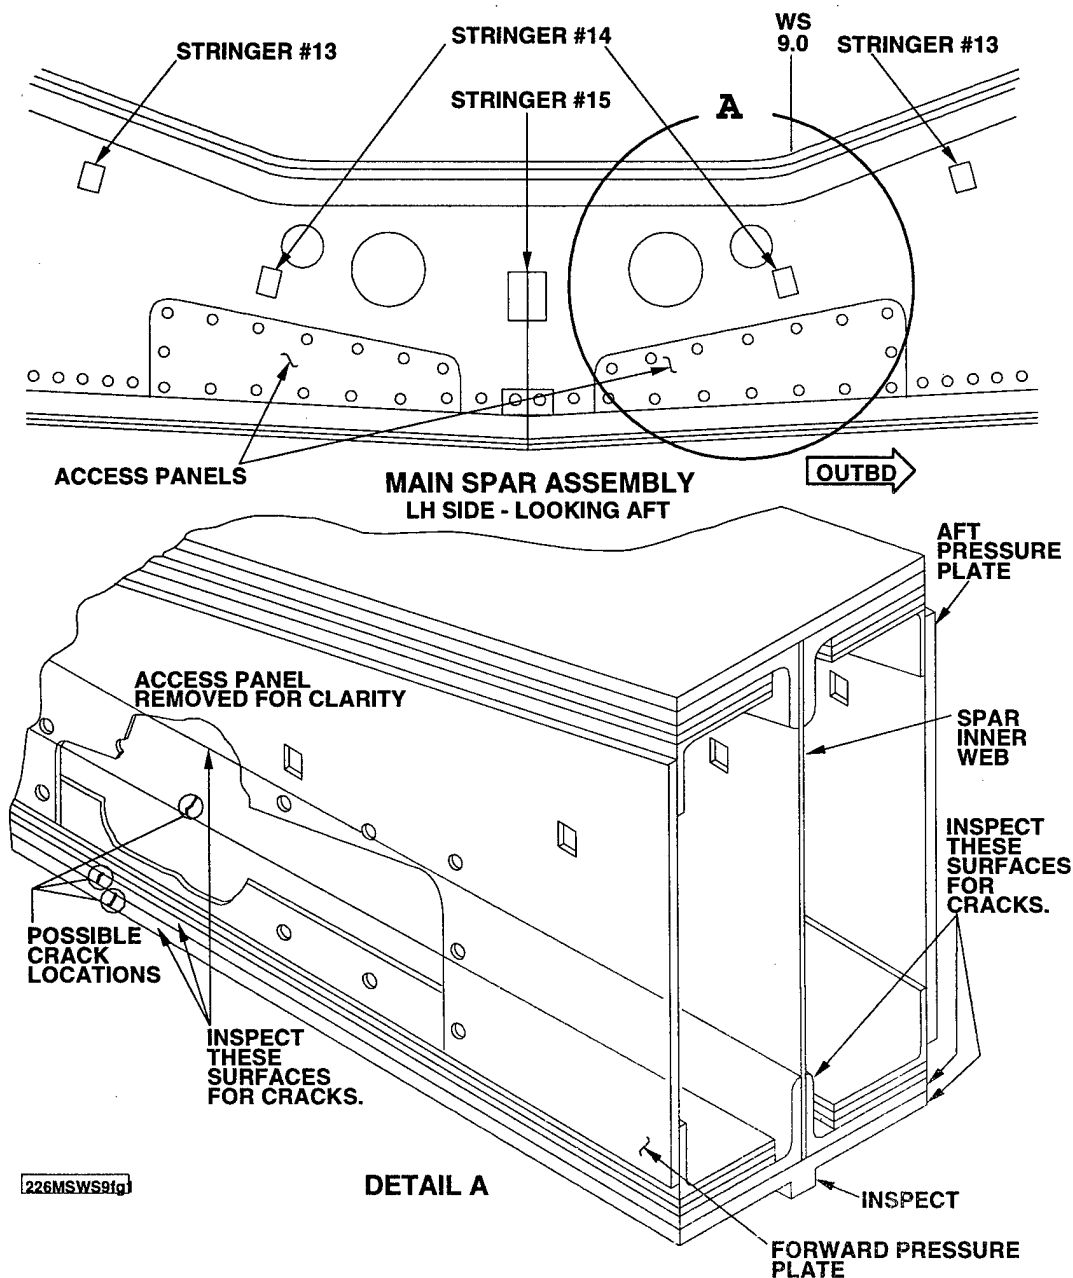
5. Detection of a crack may indicate complete failure of the part.
6. If an indication is noted, carefully repeat the inspection pass in the opposite direction to verify the indication.
7. All cracks detected shall be reported to Fairchild Service Engineering. Report the location, direction, and length of each crack.

Figure 1. SA226 Main Spar at WS 9.0

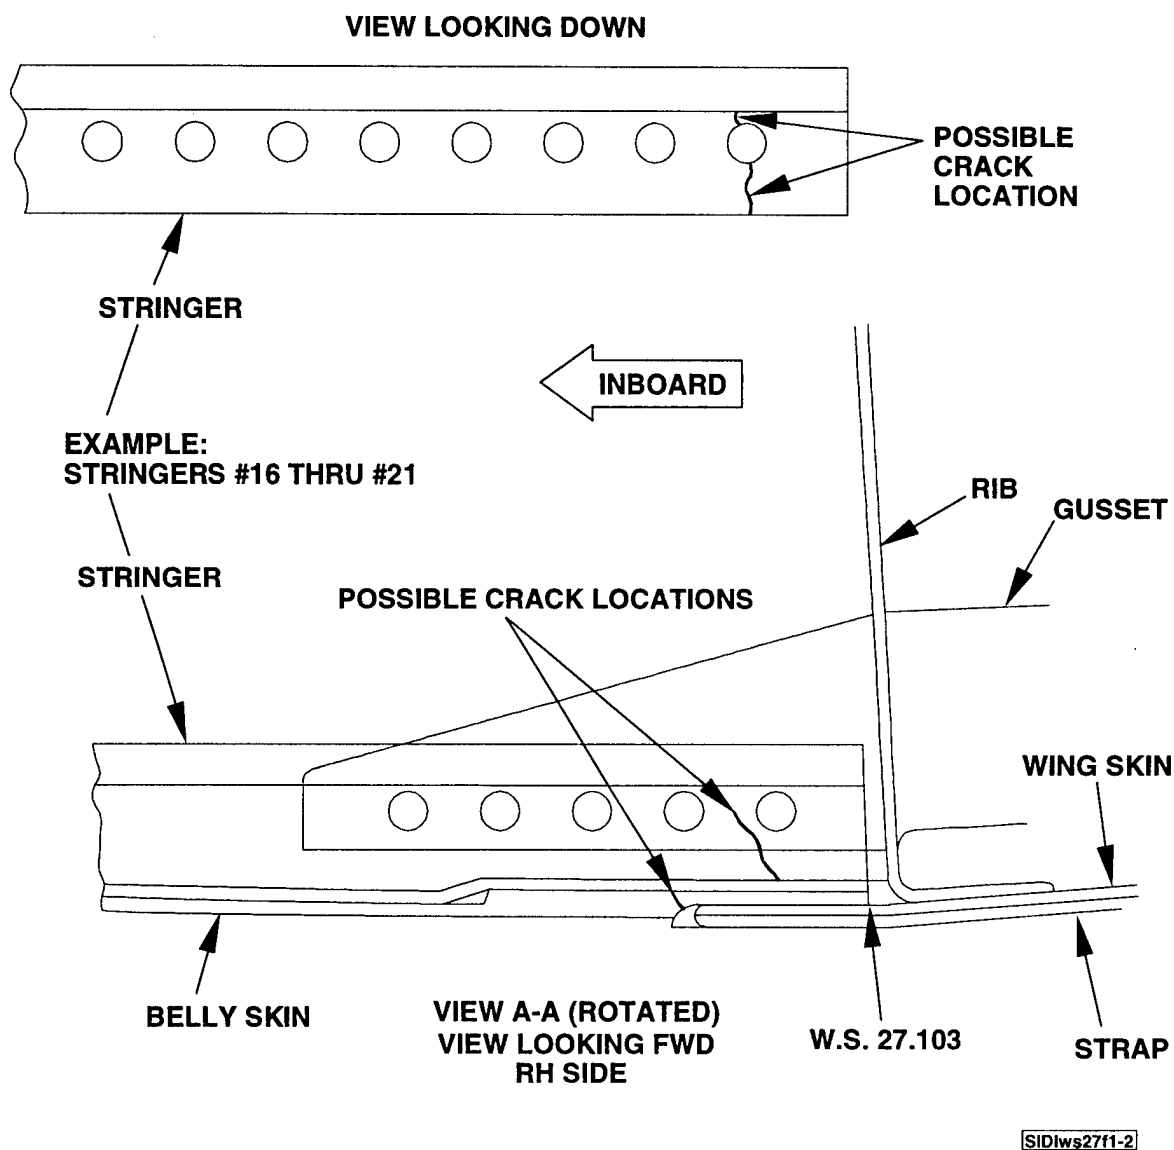
1. Adhere to procedures for Eddy-Current Inspection given in the SA226/227 Structural Repair Manual, Chapter 51-30-07.
2. Refer to Figure 1, Sheets 1 and 2. Inspect the outside surface of the belly skin just inboard of the splice strap at WS 27, left and right side, from main spar to rear spar.
3. Inspect the inside surface of the belly skin around the fastener holes in the splice just inboard of WS 27, left and right side, from main spar to rear spar. Refer to Figure 1, Sheet 2.
4. Inspect stringers 16 through 21 around the fastener holes just inboard of the rib at WS 27, left and right side. Refer to Figure 1, Sheets 1 and 2.
5. If an indication is noted, carefully repeat the inspection pass in the opposite direction to verify the indication.
6. All cracks detected shall be reported to Fairchild Service Engineering. Report the location, direction, and length of each crack.

Figure 1. SA226/SA227 Lower Wing Skin Splice at WS 27 (Sheet 2)

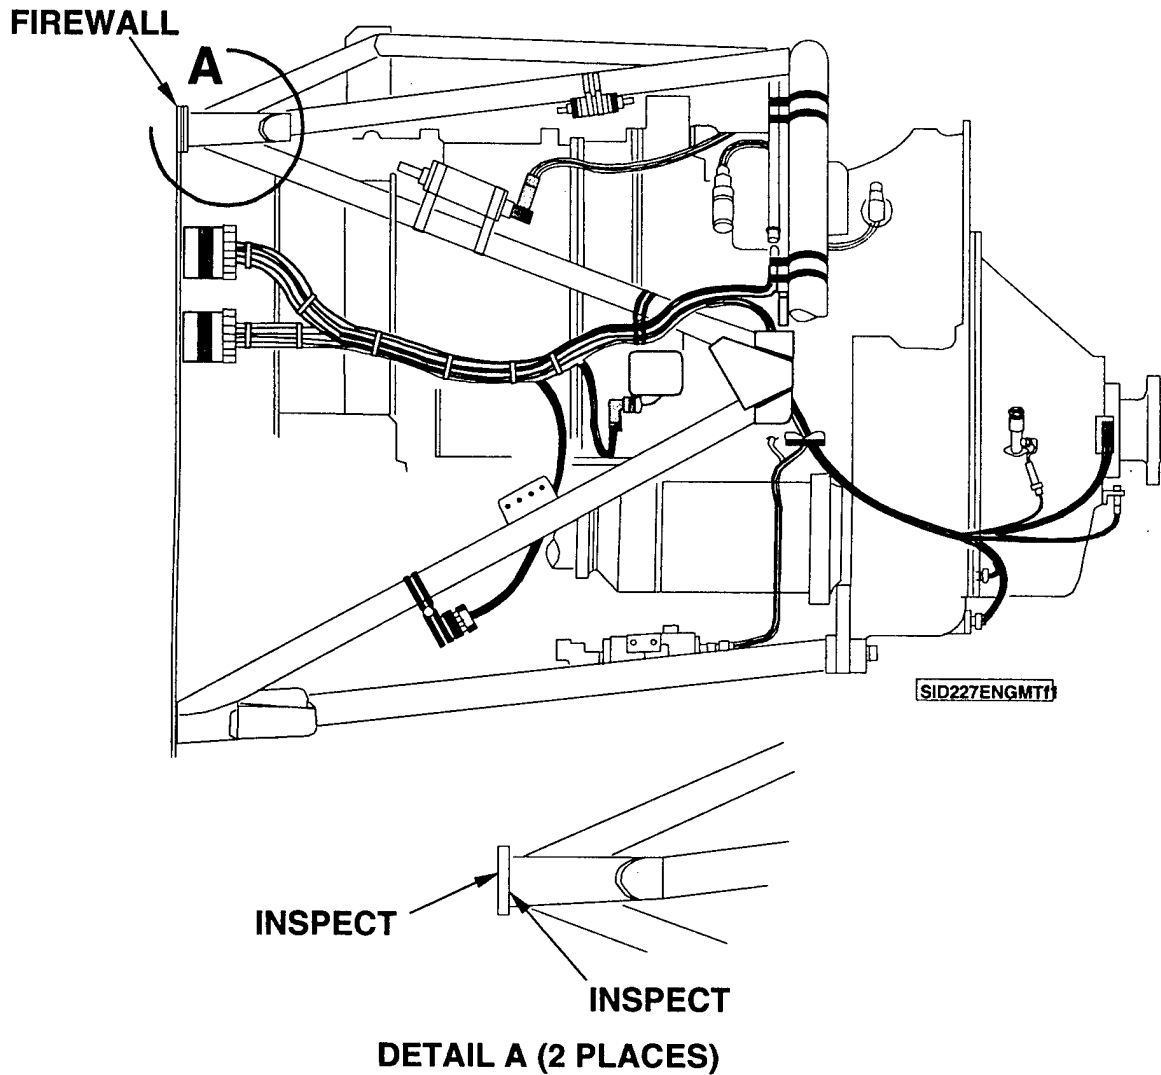
Figure 1. SA227 Engine Mount at Firewall
